Best Practice Catalog

Penstocks and Tunnels

Revision 1.0, 12/06/2011

MESA ASSOCIATES, INC.
Chattanooga, TN 37402

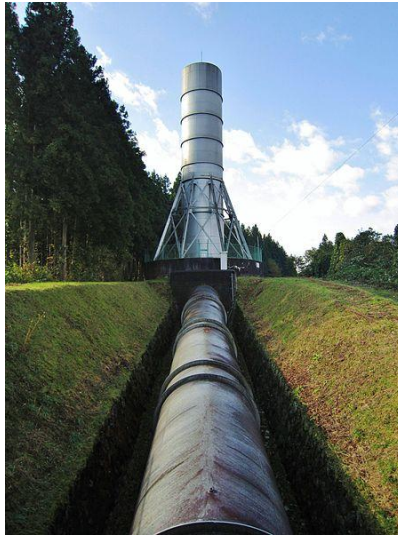
Figure 3: Steel Surge Tank at Isawa II Power Station in Japan

Surge Tanks: The surge tank is an integral part of the penstock system whose purpose is to help provide plant stability and minimize water hammer by limiting the rise and fall of pressure within the penstock. Surge tanks are also used to help regulate flow and improve turbine speed regulation. There are two categories of surge tanks: conventional open surge tank and closed air cushion surge chamber. The open surge tank can have various shapes (horizontal area as a function of elevation) and overflow arrangements. Any space that may be temporarily occupied by water during transient operation should be regarded as a surge tank (e.g. aeration pipe, gate shaft, access shaft). The air cushion chamber can reduce the total volume of the tank and can be designed for less favorable topographic conditions; however, maintenance may be needed for compressed air compensation. Surge tanks are typically excavated underground and lined with steel plate, wood, or reinforced concrete. They experience issues similar to that of penstocks such as deterioration or corrosion of tank material, breakdown in coatings and linings, and damage or deterioration to tank mechanical appurtenances. Figure 3 shows an example of a surge tank erected on the ground surface.

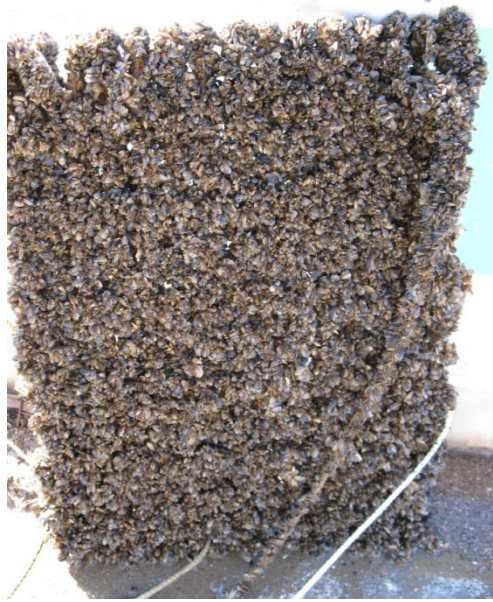
Figure 4: Invasive Zebra Mussels on Steel Surface

The internal surface roughness of penstocks contributes to head loss and can often be reduced to yield an increase in efficiency. “In one plant studied where the penstock is 130 feet long a net gain of head of 0.65 feet could be realized by replacing the riveted penstocks with welded steel, spun-tar lined penstocks. The generation gain would be more than one million kWh per year [8].” Surface roughness reductions can also be achieved by coating the inside of the penstock. Many different coating materials are available and the use of a specific material type will be dependent on project-specific needs. Some coatings not only improve surface roughness but can also prevent organic buildup. These coatings, such as silicone-based fouling release systems, should be considered where bio-fouling is a design consideration. Surface roughness may also be reduced by scrubbing and cleaning the interior of the penstock, removing buildup of foreign material such as invasive zebra mussels as shown in Figure 4. In one study, the surface roughness of two identical steel conduits was examined. One conduit surface was considered “quite smooth” while the other had accumulated significant organic buildup. The average Darcy friction factors under normal operating conditions were calculated at 0.13 for the smooth pipe and 0.20 for the pipe with buildup [3]. By restoring similarly affected penstocks to their original surface conditions, plant operators could expect comparable results, possibly reducing friction head losses by up to 35%, as in the case study.

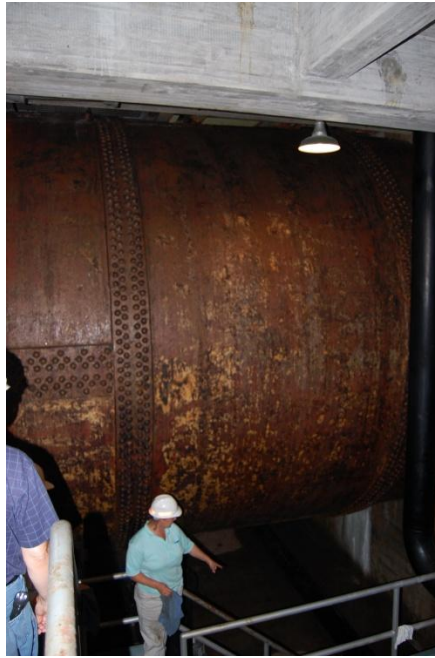
Figure 5: Exposed Portion of Penstock at Center Hill Hydro Plant in DeKalb Co., Tennessee
